The 1916 catastrophic flood following the Bílá Desná dam failure: The role of historical data sources in the reconstruction of its geomorphologic and landscape effects

Pavel Raška^{a,*}, Adam Emmer^b

^a Jan Evangelista Purkyně University, Ústí nad Labem, Czech Republic

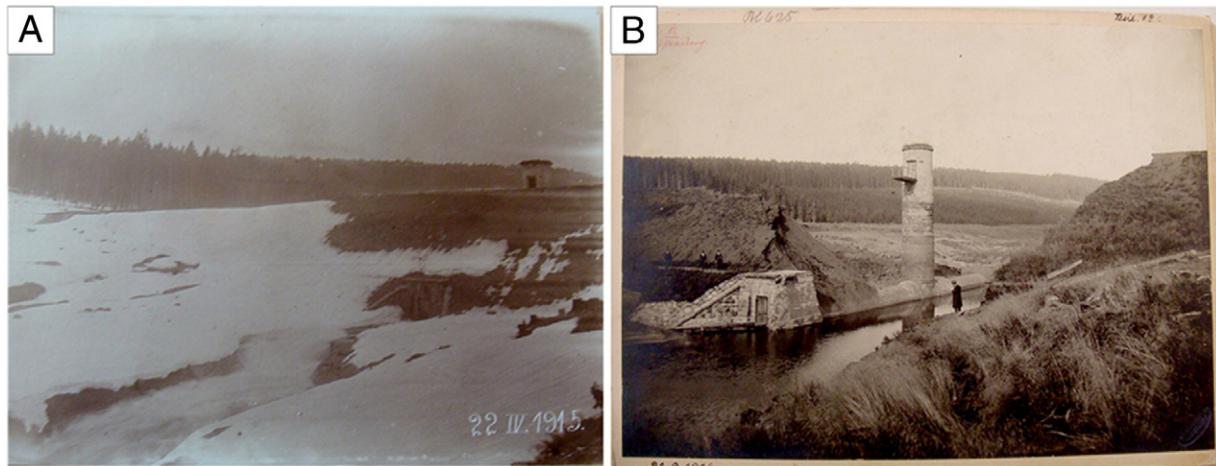
literature (Smrček, 1917; Žák, 1996; Žák et al., 2006) and from archival documentary data. The first evidence of piping through the dam was observed by loggers returning from work along the dam at 15:30 h. At that moment, 290,000 m³ of water was retained in the reservoir. The dam keeper ordered the immediate draining of the reservoir by the full opening of the dam outlet; nevertheless, the piping continued, and the flow rate was exponentially increasing. At 16:00 h, the inhabitants living downstream in the Desné village were warned for the first time by telegraph against the increasing discharge from the dam. Fifteen minutes later, at 16:15 h, the dam failed with an accumulated water volume of 250,000 m³. The village of Desná inhabitants were warned again against a flood following the dam failure at that time. An additional thirty minutes later, at 16:45 h, the dam was completely empty (Fig. 4). The escaped water swept through the valley, leaving behind 62 fatalities and tremendous material damage.

Fig. 4. Upstream view of the Desná dam before (A) and after (B) the dam failure. Source: Archive of the Jablonec nad Nisou, Court reports.

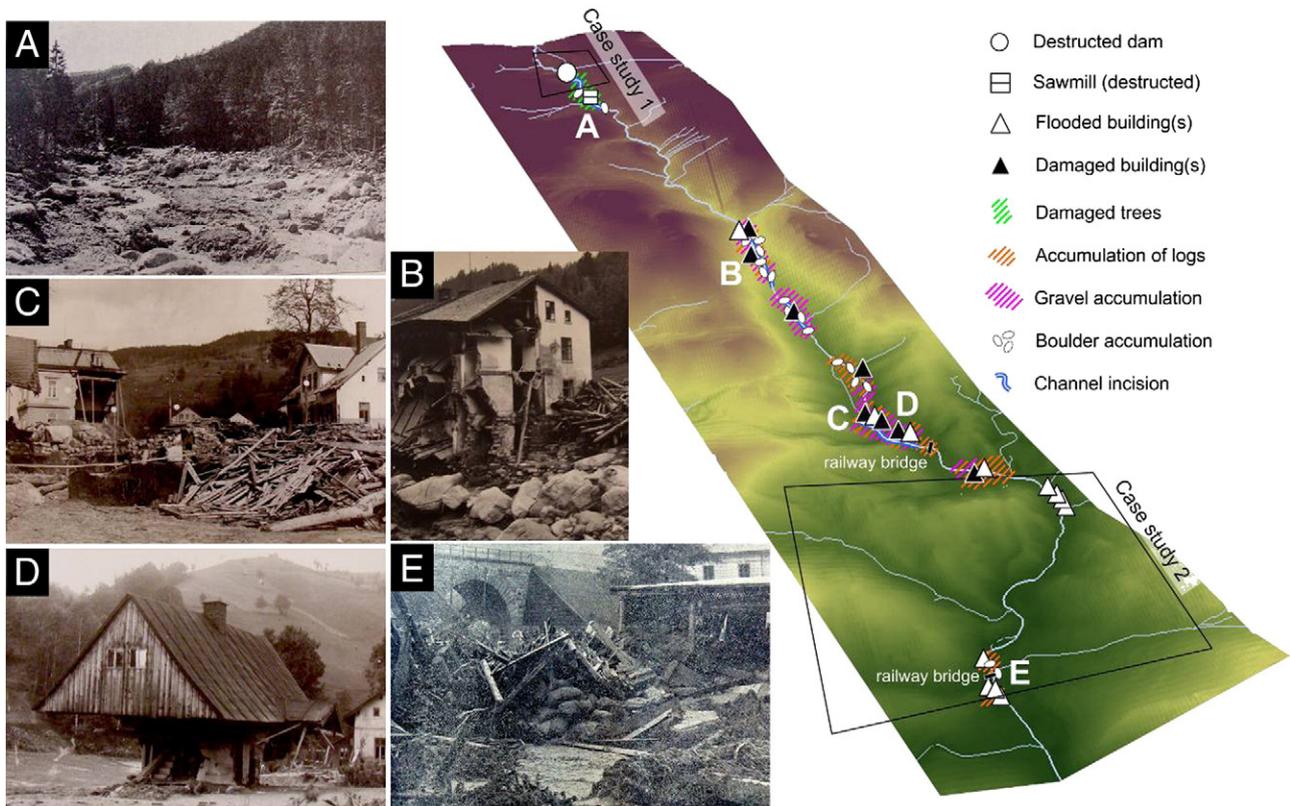
Fig. 6 shows the identified effects of the flood along the river between the failed dam and the town of Tanvald. The detected effects include (i) damage to buildings and to infrastructure and (ii) modifications of the river channel (erosion and accumulation processes), and their intensity can be divided into three segments relative to the longitudinal profile of the Bílá Desná River (Fig. 1D). More than one-third of the studied river length (0–3.2 km) is situated in a narrow intra-mountain valley, with an average slope inclination of ca. 2.80° (806–650 m asl).

Fig. 6. Effects of the flood along the Bílá Desná River based on documentary data. Note: Of the large amount of documentary data, only those data that could be exactly localised were used.

The high gradient of this river segment enabled the stream to transport a large amount of material, which consisted of fractions varying from sand to boulders of up to 2 m in diameter. The flood wave damaged the forest ecosystem in the narrow valley, and the channel underwent a lateral shift (see below in case study 1) and a slight incision in some segments. After reaching the end of the narrow valley, the Bílá Desná River reaches the open space with the settlement of the village of Desná. Between 3.2 and 5 km, the gradient slightly increases to ca. 3.8° as the river channel enters the foothills; however, this gradient gradually decreases from 5 km downstream. The decrease in the gradient, which causes a loss of flow velocity, resulted in the gradual, but massive, deposition of boulders and of timber (approximately between B and D in Fig. 6) that damaged or destroyed tens of buildings, including a few industrial facilities (Gnendiger, 1920) in this river segment. The woody buildings localised near the channel and in the open floodplain (D in Fig. 6) were primarily affected. Owing to the transformation of the flood wave, the last analysed segment of the river (approximately within case study 2) was primarily affected by flooding; however, the destruction of buildings was not frequently documented. This lack of documentation can be ascribed to not only the increasing share of buildings constructed from stones and bricks in this segment but also the decreasing volume of boulders and timber that reached the lower parts of the river. In contrast, the documentary evidence has shown that part of this transported material (both timber and boulders) reached as far as the railway bridge in Tanvald (E in Fig. 6), ca. 8 km below the failed dam.

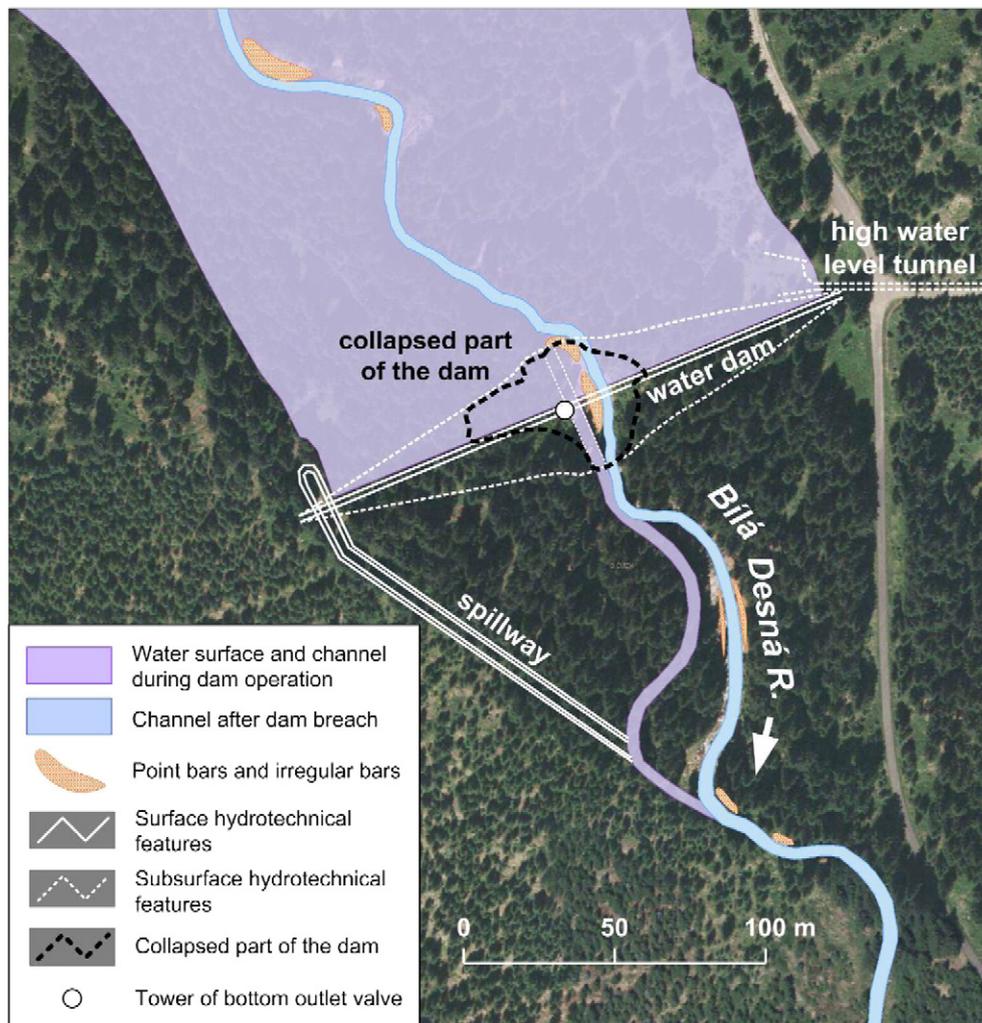
4.1.3.1. Case study 1. The disturbance and modification of the valley and riverbed of the Bílá Desná River following the dam failure has been reconstructed in case study 1, which covers the area of the former reservoir (see Fig. 1). The detailed reconstruction of other river reaches could not be performed because of the limited availability of old maps and photos. Following the dam failure and the rapid discharge of 250,000 m³ of accumulated water during only 30 min, the channel below the dam was significantly modified. The comparison of historical maps from investigation reports of the event and of aerial photos from the early 1950s and from 2010 has shown that the meandering channel below the dam was subject to channel migration and lateral accretion (Fig. 7). The channel width in the reach below the former reservoir varied around 5 m before the dam failure and is currently 8 m in average. The magnitude of channel migration reached up to 30 m in the second meander below the former dam, whereas the lateral accretion only slightly increased the sinuosity of the channel. Instead of channel straightening (cf. Pizzuto, 2002), which could be expected as a result of flood wave flow, the return to the original meandering channel seems to be caused by geometry of a dam-breach and by extreme discharge that disrupted the channel geometry artificially established during the dam construction. This seems to be caused by the disrupting impact of the flood wave caused to channel segments. As documented by cadastral maps from the mid-nineteenth century, the Bílá Desná River channel approximately returned to its original position before the dam construction, with a meandering pattern. The reestablishment of the meandering

Fig. 7. Changes in the channel morphology after the dam failure.

channel pattern and increased sinuosity by lateral accretion enabled the evolution of several gravelly points and irregular bars, which are characteristic of other high-gradient streams in the area. According to Costa and O'Connor (1995), the above-described geomorphic changes are characterised as 'extreme disruptions' of the river channel.

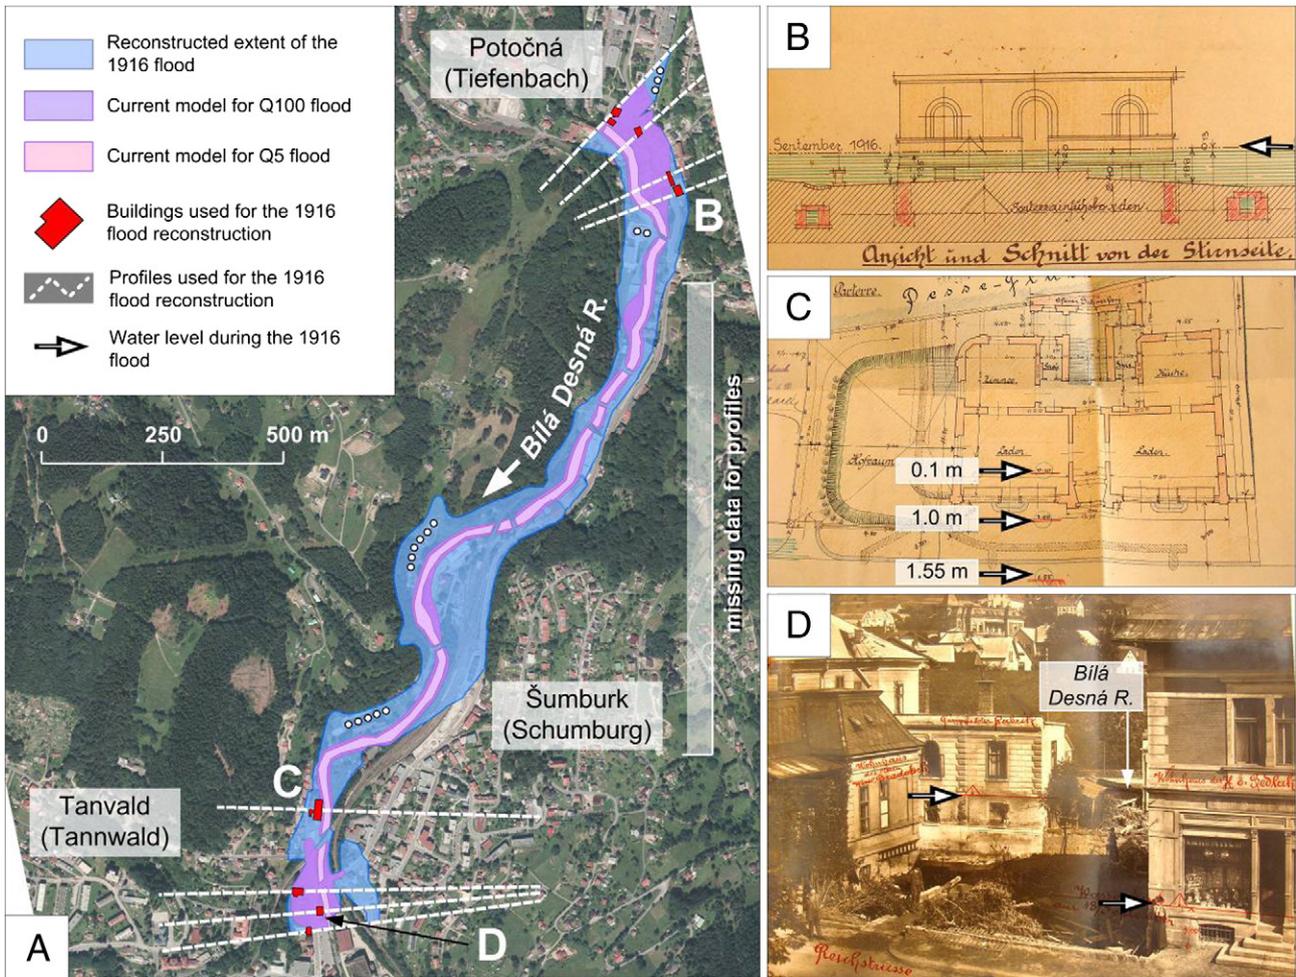
The width of the flooded area ranged between ca. 50 and 250 m, with the highest width reached in built-up areas of the towns and in the meandering channel in the central part of the studied channel reach. In contrast, the minimal width was typical of narrow valley segments, where an increase in the flow velocity can be expected. However, the documentary data did not provide the cross profiles for the central part of the studied river reach. Therefore, the results for this part of the area must be considered only rough estimations. According to the classification presented by Costa and O'Connor (1995), this part of the Bílá Desná River channel was affected by 'small disruptions' from the point of view of geomorphic impacts.

The comparison of the reconstructed flood wave extent with available current flood maps (VÚV, 2014) has shown that the flood wave following the 1916 dam failure exceeded the width of Q_5 and Q_{100} floods 10 times and 5 times, respectively, at some locations. This result can be ascribed to both the extremeness of the peak discharge reached after the dam failure and the subsequent modifications of the Bílá Desná River channel during the last 100 years.

Fig. 8. Estimated flood wave extent. Part (A) illustrates the flood wave extent and the Bílá Desná River valley cross profiles. White dots for major changes in built-up areas after 1916 within the estimated flood wave extent (see Section 4.1.3 for further explanation). Examples of documentary evidence for the flood wave extent and the water level, as preserved in investigation reports for insurance companies. Cross-profile (B), plan (C), and photo (D) with an indicated water level mark.

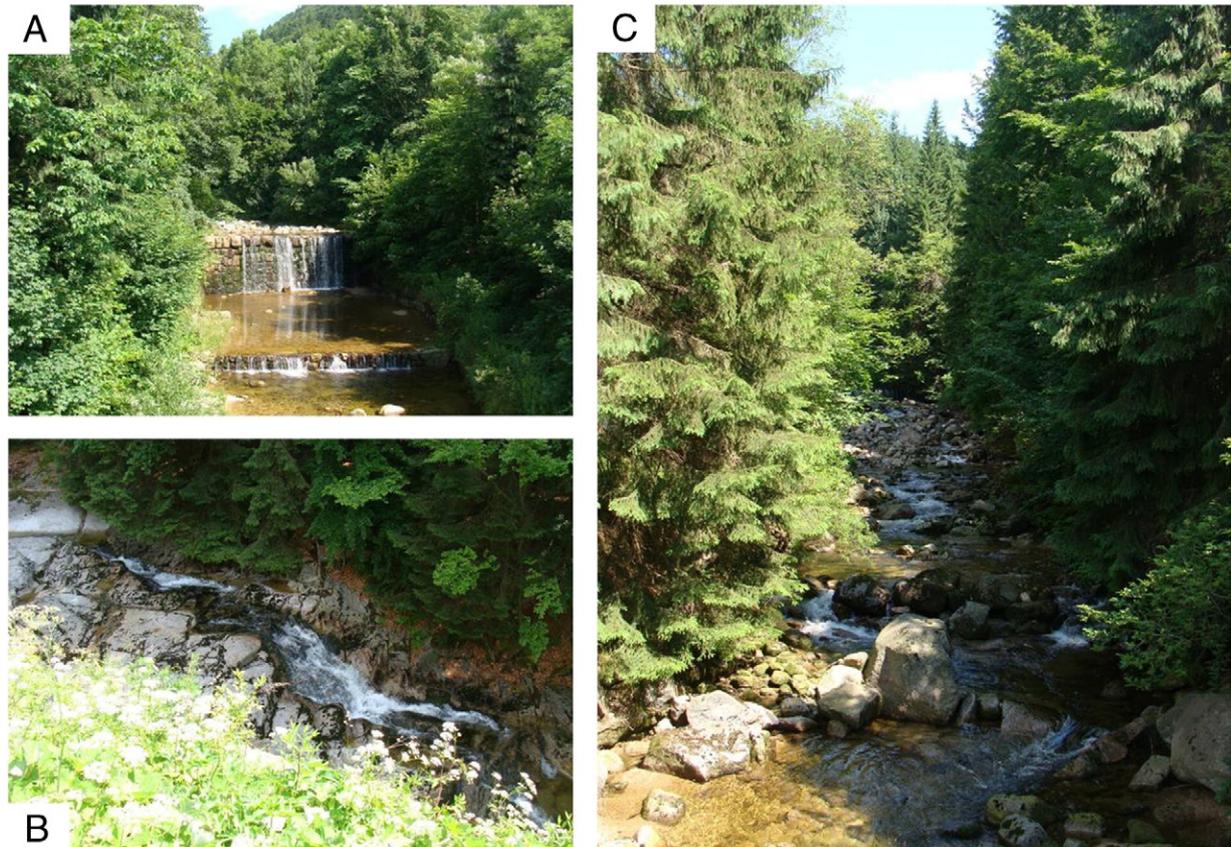
Fig. 9. Part (A) shows an example of stony steps built into the steeper part of the Bílá Desná River channel to protect against floods (debris flows). Part (B) shows a natural bedrock-based part of the river channel bottom. Part (C) shows a natural (unremediated) part of the Bílá Desná River channel.

modified between 1923 and 1936. These technically demanding and expensive remedial works included the complete pavement of the river bottom along the 1.5-km-long lower part and the construction of 34 stony steps in the steeper 2-km-long upper part (Fig. 9A); bedrock-based parts of the river bottom were left without modifications (Fig. 9B). The stony steps are between 1.0 and 4.2 m high and 11.0 to 18.0 m long and serve as a sediment trap (prevention against the initialisation of debris-flow movement). All of these artificial elements are designed for a maximal flow rate of $60 \text{ m}^3 \text{ s}^{-1}$ (Žák, 1996). The section from the upper part of the village of Desná to the former Desná dam position has a natural character, with no artificial channel modifications (Fig. 9C).
