The 1916 catastrophic flood following the Bílá Desná dam failure: The role of historical data sources in the reconstruction of its geomorphologic and landscape effects

Pavel Raška^{a,*}, Adam Emmer^b

^a Jan Evangelista Purkyně University, Ústí nad Labem, Czech Republic

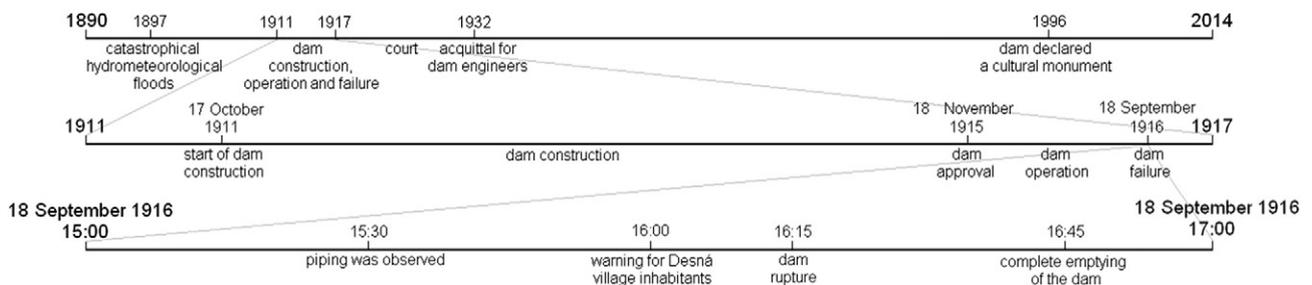
Fig. 3. Chain of events connected to the Desná dam failure (according to Smrček, 1917; Žák et al., 2006).

The Bílá Desná dam construction began in 1911 because of discussion concerning the construction of dams in the Jizerské Mts., which started after catastrophic hydrometeorological floods at the end of June 1897 and finished four years later with dam approval on 18 November 1915 (Fig. 3). The longevity of the dam was only 10 months, before the dam failed on 18 September 1916.

literature (Smrček, 1917; Žák, 1996; Žák et al., 2006) and from archival documentary data. The first evidence of piping through the dam was observed by loggers returning from work along the dam at 15:30 h. At that moment, 290,000 m³ of water was retained in the reservoir. The dam keeper ordered the immediate draining of the reservoir by the full opening of the dam outlet; nevertheless, the piping continued, and the flow rate was exponentially increasing. At 16:00 h, the inhabitants living downstream in the Desné village were warned for the first time by telegraph against the increasing discharge from the dam. Fifteen minutes later, at 16:15 h, the dam failed with an accumulated water volume of 250,000 m³. The village of Desná inhabitants were warned again against a flood following the dam failure at that time. An additional thirty minutes later, at 16:45 h, the dam was completely empty (Fig. 4). The escaped water swept through the valley, leaving behind 62 fatalities and tremendous material damage.

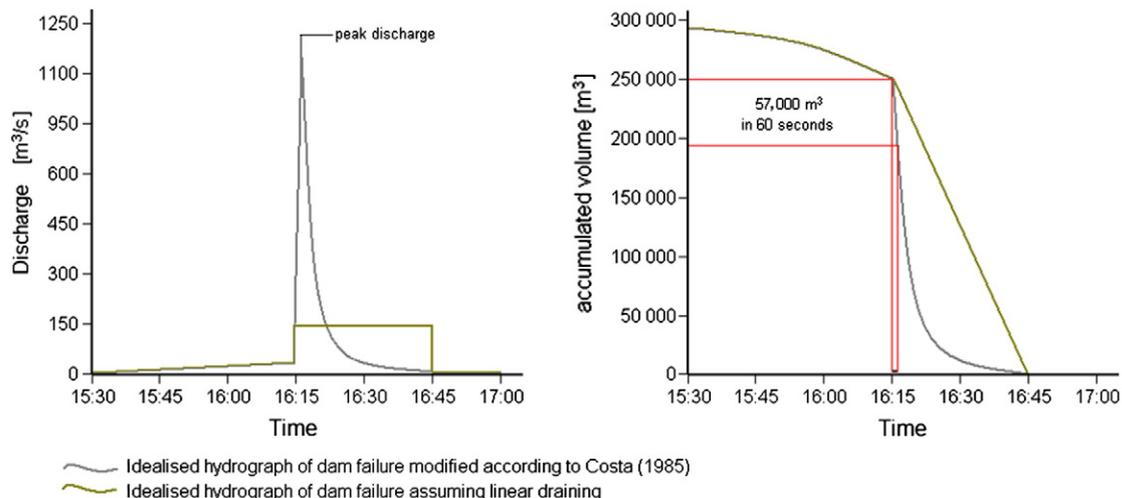
Fig. 5. Approximate hydrograph of the event (based on the recorded time sequence of the dam failure).

Another point of view concerning the Desná dam failure is represented by a hydrograph describing the change in the flow rate and the decreasing volume of accumulated water between 15:30 h and 16:45 h on 18 September 1916 (Fig. 5). Costa (1985), and later by Tsakiris and Spiliotis (2013), showed that hydrographs describing earthen dam failures are particularly characterised by a steep rising limb and by a steep falling limb, with a peak discharge within minutes to hours, depending on the accumulated water volume, dam characteristics, and failure mechanism.

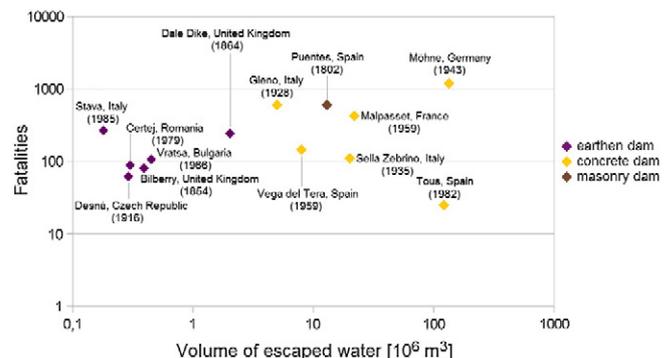
Fig. 10. Comparison of the most catastrophic European dam failures. (Data: Harrison, 1974; Costa, 1985; Alcrudo and Mulet, 2004; Peng and Zhang, 2012).

In comparison with recorded floods following dam failures in Europe, the Bílá Desná dam failure claimed a high number of fatalities relative to the volume of escaped water (Fig. 10). The discharged volume of 290,000 m³ and 62 fatalities provide an extremely catastrophic ratio of 4677 m³/victim. From this point of view, the Bílá Desná dam failure is considered one of the worst dam failures ever recorded worldwide. In the regional context of the Czech Republic, no recorded hydrometeorological flood (e.g., the great floods in 1997 and in 2002) claimed such fatalities. According to the number of fatalities, this event is currently ranked among the most catastrophic earthen dam failures in Europe. When we consider the time of the dam failure, this event was ranked as one of the most catastrophic dam failures until 1916 and, therefore, significantly affected the engineering of earthen dams in the entire Central Europe region (Žák, 1996).
